Case Study
S. Ark. – N. La.

- **Historical Site**
- **Salt Water Disposal**

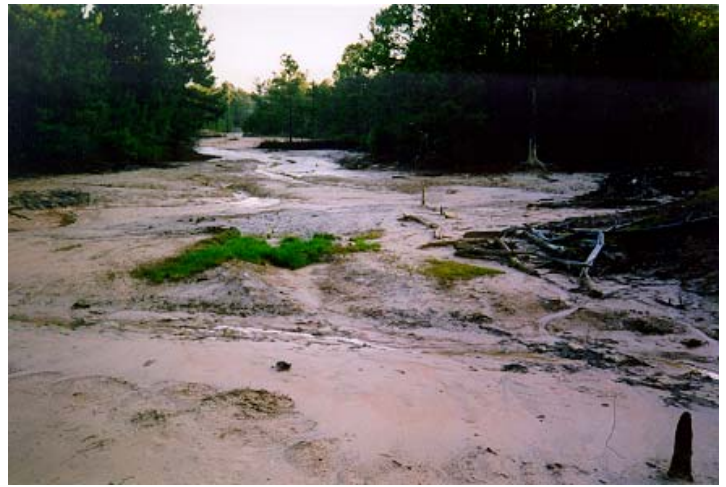
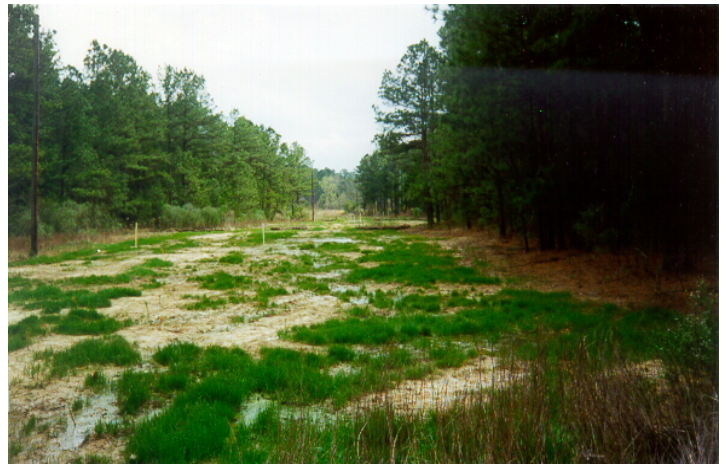
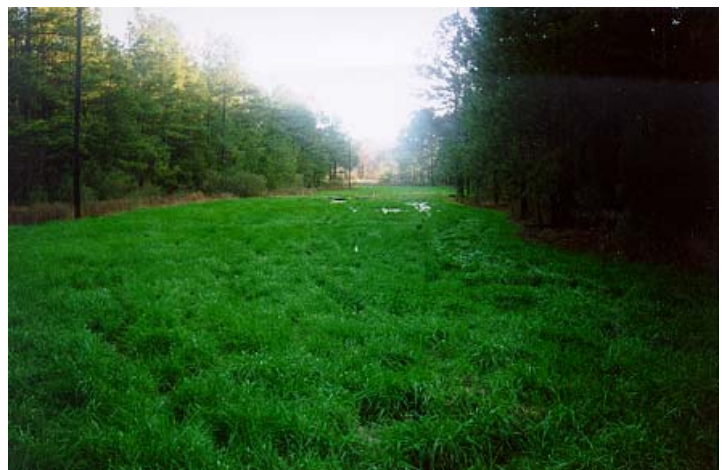
Site Condition

- **Sodic Soil**
- **Sandy Clay**
- **Top Soil Erosion**

Test Seeding
Replanting of Native Grass

Time Lapse = 24 mos.

- **Install drain system**
- **Deep plow and bulk soil**
- **Apply amendments**
- **Flush with water**

- ***DeSalt Plus***™
- ***DeSalt***™
- ***GeoRinse***™
- ***JumpStart***™
