Case Study Gregg County, TX

- Historical Site
- Salt Water Disposal Pit

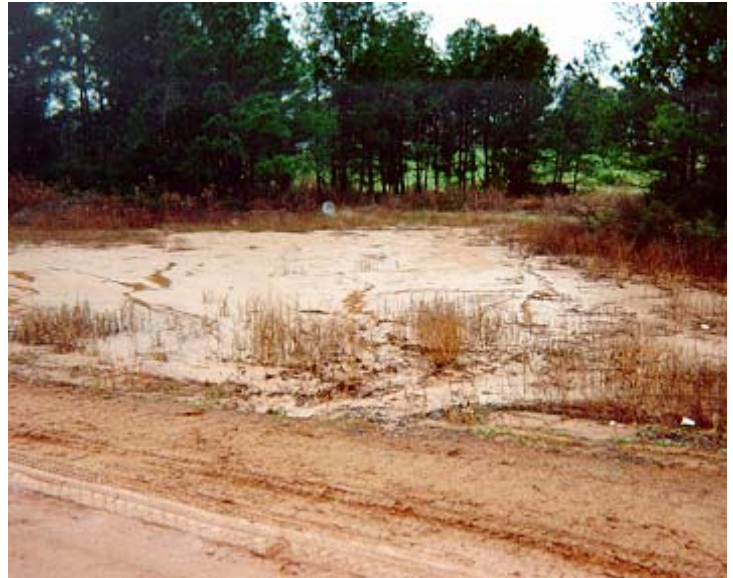
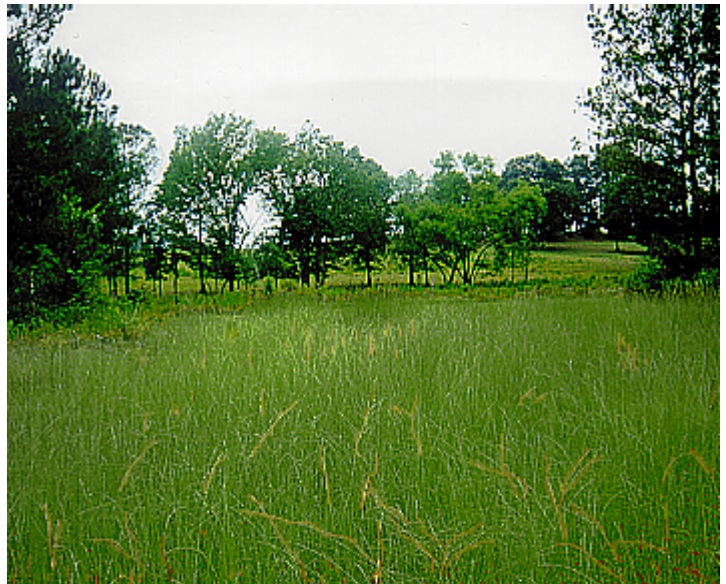
Site Condition

- Sodic Soil
- Top Soil Erosion
- Sandy Clay

EC 12
SAR 27
ESP 50
CEC 5

Time Lapse = 12 mos.

Treatment

- Deep plow and bulk soil
- Apply amendments
- Flush with water

Amendments Applied

- *DeSalt*™
- *DeSalt Plus*™
- *GeoRinse*™

Re-seed with native grass
