Case Study Harris County, Texas

- Historical Site
- Salt Water Disposal System

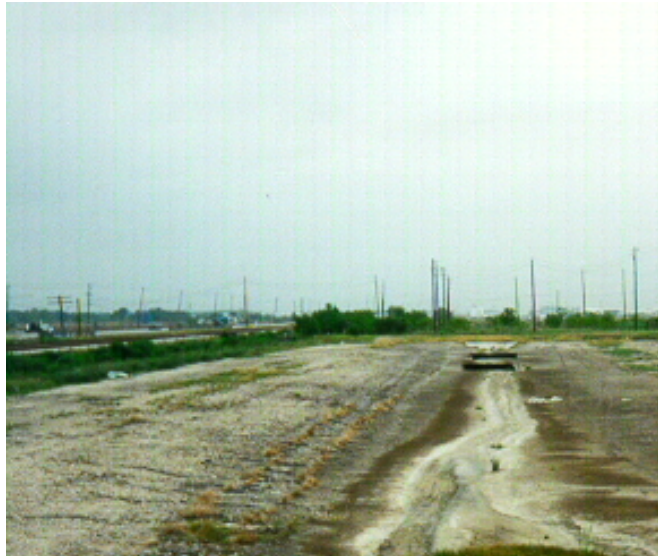
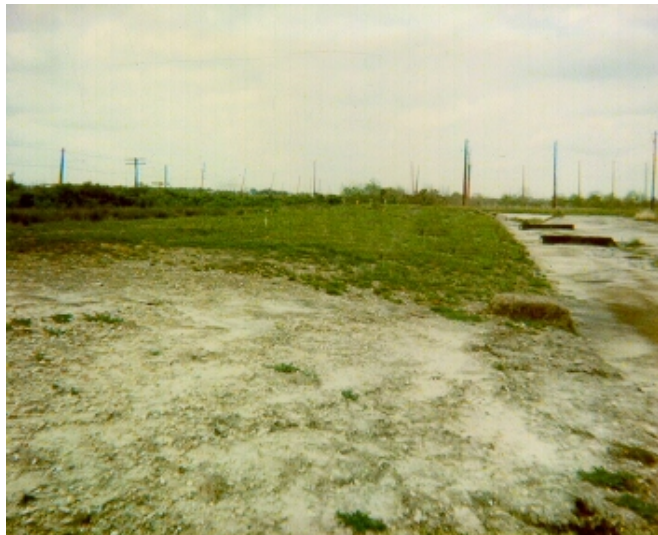
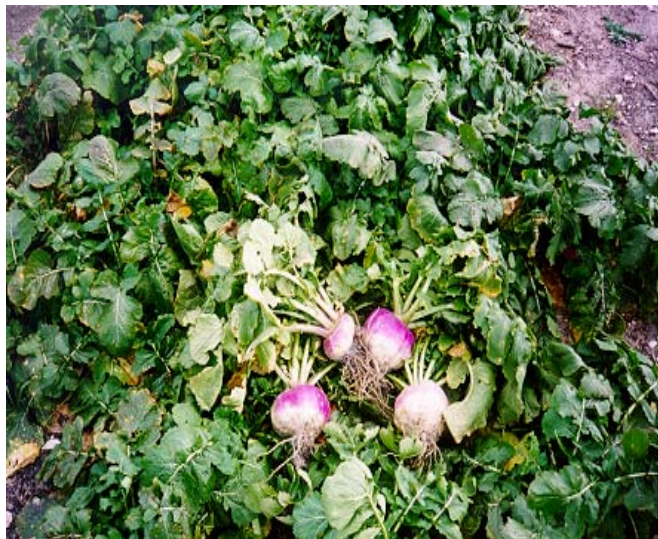
Site Condition

- Φ Sodic Soil
- Φ Heavy Clay

EC	77
SAR	125
ESP	93
CEC	40

Time Lapse = 18 mos.

- Φ Deep plow and bulk soil
- Φ Install drain pattern with bulking materials
- Φ Applied amendments
- Φ Irrigate

- Φ *DeSalt*™
- Φ *DeSalt Plus*™
- Φ *GeoRinse*™

Re-seed with native grass
