Case Study
Terrebonne Parish, Louisiana

- **Historical Site**
- **Salt Water Disposal Pit**

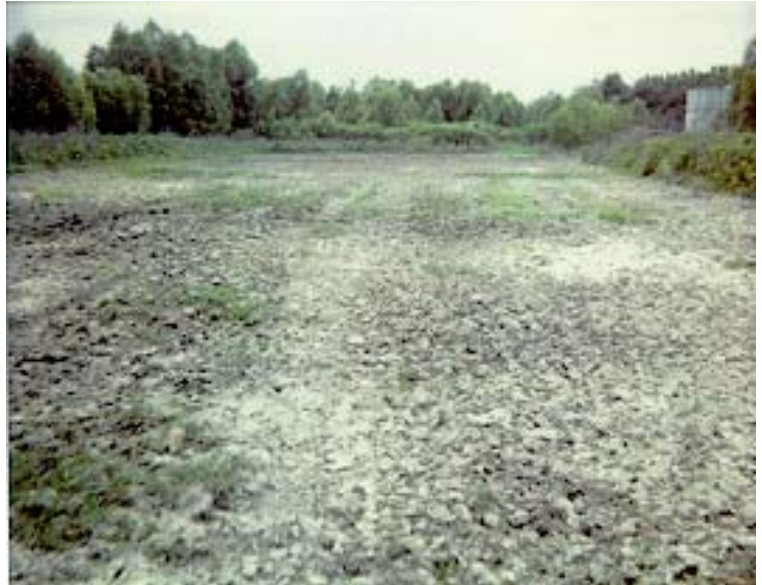
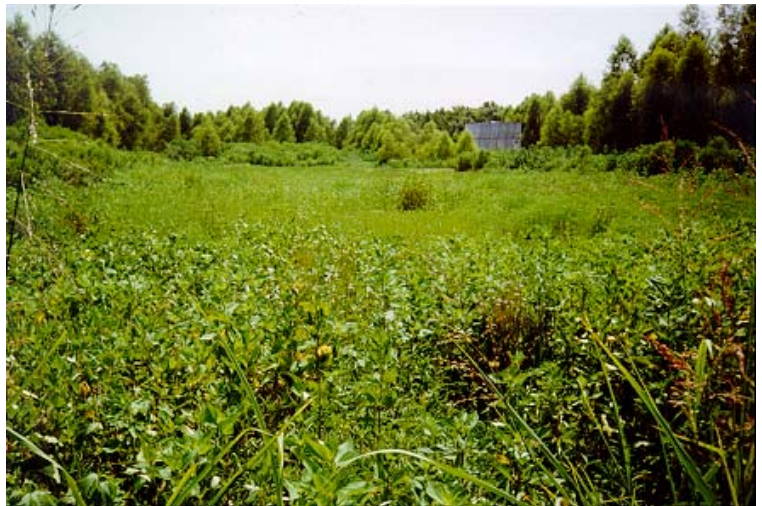
Site Condition

- **Sodic Soil**
- **Heavy Clay**

EC 20
SAR 30
ESP 43
CEC 46

Time Lapse = 18 mos.

Treatment

- **Disc soil**
- **Apply amendments**
- **Flush with water**

Amendments Applied

- ***DeSalt™***
- ***GeoRinse™***

Test Seeding

Re-seed with native grass
